# SEED FINAL REPORT

## Assessment of Historic Concrete and Masonry by Broadband Vibration Testing

SERDP SEED Project RC-1653

August 2010

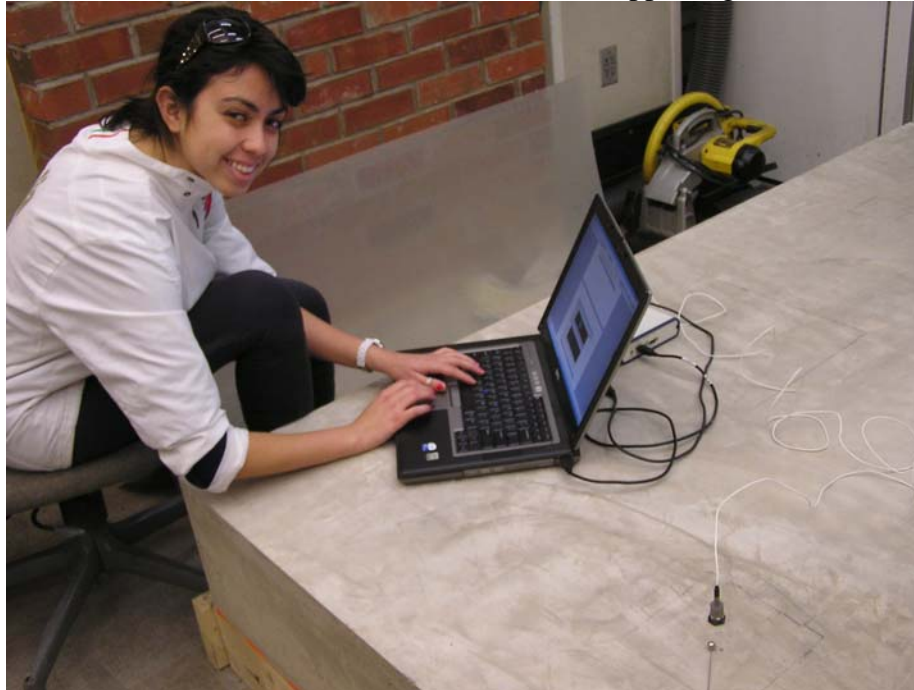
Figure 1: Accelerometer testing of a test slab, including operator, computer, data acquisition module (partially concealed behind computer and accelerometer).

*Accelerometers:* PCB model 352A78 ceramic shear accelerometers were selected for the prototype EMA/IE system. These accelerometers were chosen because their flat calibrated frequency response characteristics ( $\pm 2.5\%$  from 5 Hz to 10 kHz, and  $\pm 5\%$  from 10 to 15 kHz) enable their use for both EMA and IE assessments. Actual achievable frequency response is dependent on accelerometer mounting technique. Threaded stud mounts are incorporated in the accelerometers to which adhesive mounting bases are attached with a light film of silicone grease to improve vibration transmissibility. When cyanoacrylate or epoxy adhesives are used to attach the mounting pad to the material under test at each measurement point, this technique can yield acceptable performance up to 20 kHz. The application of this equipment is depicted in Figures 1 and 2.

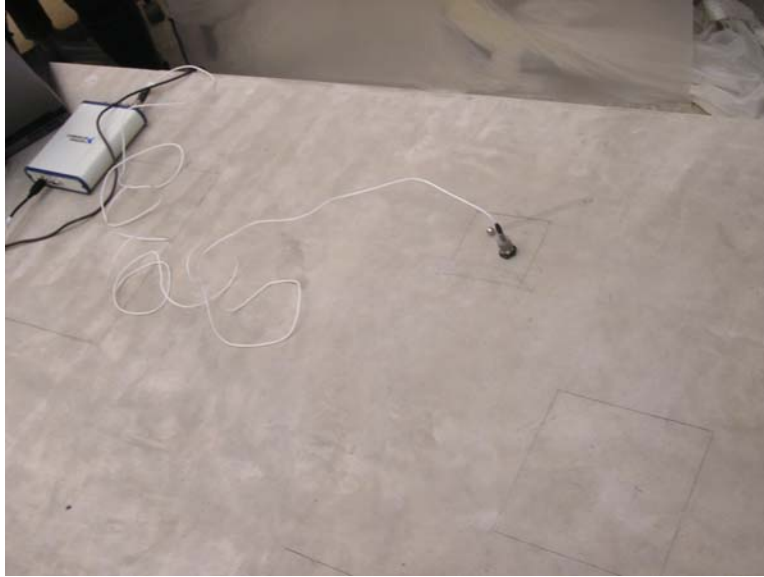
Figure 2: Accelerometer testing of slab, showing data acquisition module and accelerometer. The pencil lines on the slab represent the location of the included defects. The accelerometer is positioned over defect number 4 (described under Trial of Equipment: Laboratory).

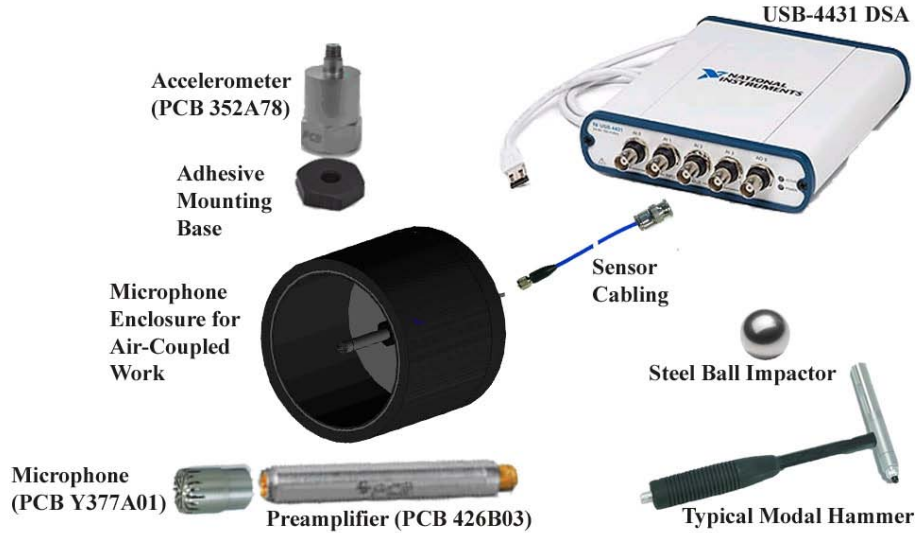
Figure 4: Prototype EMA/IE system.

*Data acquisition and control hardware:* Data acquisition and control within the prototype system is accomplished using a National Instruments (NI), model USB-4431 Dynamic Signal Analyzer with a 102 kHz bandwidth appropriate for impact echo-only, modal-only or combined impact echo/modal analysis investigations. Power to the device is supplied by the universal serial bus (USB) bus interface of a personal computer (PC) or laptop running the Windows operating system (OS). Four channels of simultaneously acquired analog input, one channel of analog output and eight digital input/output (I/O) lines can be flexibly configured to offer a number of testing configurations with this setup. Analog input lines are alternating current (AC)-coupled to provide the excitation and signal conditioning for integrated electronics piezoelectric (IEPE) accelerometers, microphones and other piezo-based devices. NI compactDAQ 9401 (twenty four channel digital I/O) and 9481 (four channel AC/DC relay modules) housed in USB bus powered carrier housings expand on the capabilities of the 4431 module to provide full automation of the impactor equipment described. Figure 4 shows schematically the use of the dynamic signal analyzer.

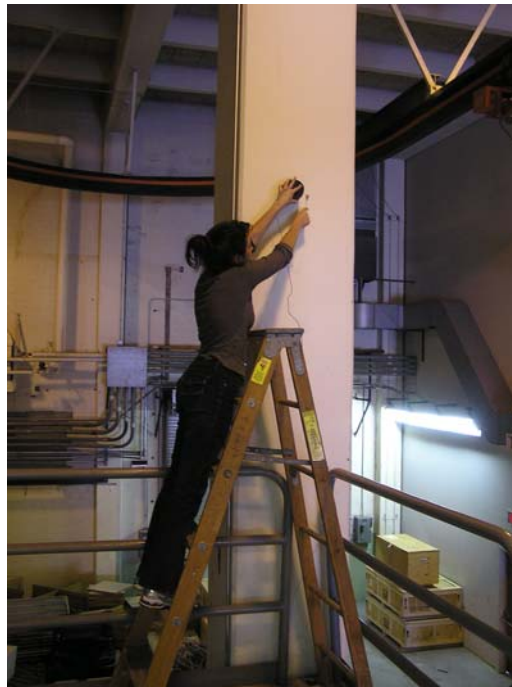
Additional tests were performed on one of the central columns in Building 18F. Air-coupled impact echo tests were completed at four different levels of the column. In the accelerometer based procedure, an accelerometer was adhered to each side of the column, using a micro-crystalline wax. The column was impacted near the accelerometer, and the acceleration results were transformed to the frequency domain for interpretation. The air-coupled procedure was similar, but a microphone enclosure with a microphone was substituted for the accelerometer. This testing, completed on March 18, 2010, is illustrated in Figure 11.

Figure 11: Air-coupled impact-echo test on a column: Building 18F.

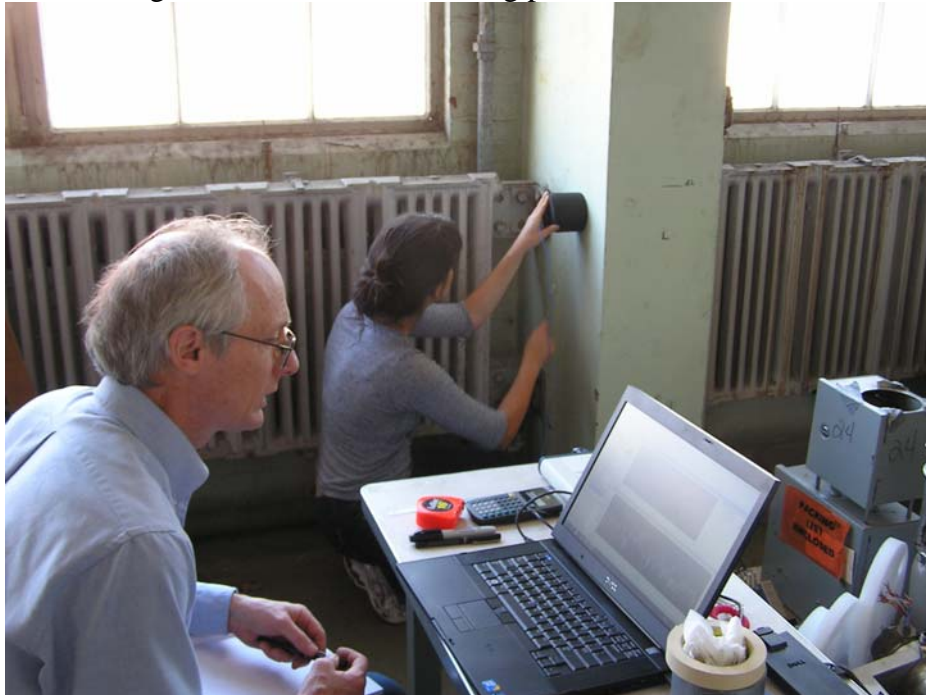
Many of the plain concrete pedestals supporting the columns in Building 19 display patterns of cracking. The most commonly occurring crack is a horizontal crack through the pedestal at approximately mid-height, but in other cases diagonal cracking initiating at the horizontal crack and stand-alone diagonal cracking are observable. Impact-echo testing was performed on a number of the pedestals, some with observable cracking, and some without observable cracking. A sample of the pedestals in Building 19, was also tested using air-coupled impact-echo analysis. The pedestals have dimensions of 12"  $\times$  24" in plan, and a height of 72" above the floor. The pedestals were tested at three elevations across the 12" width, along the 24" length, and also tested once along the height. The aspect ratio of the pedestal in the 12" (transverse) direction qualifies it to be considered as a plate structure, and is the most favorable for impact-echo testing, while in the perpendicular direction, the pier is considered as transitional between a plate and a rod. In testing along the height, the pier is considered to behave as a rod. The pedestals have designations N (north) or S (south), and are numbered from 1 to 10 beginning at the east end of the building. The pedestals on the north side of the building display the greatest damage, while those on the south side appear substantially undamaged. The pedestals tested were 3N, 6N, 7N, 8N, and 8S. Figure 12 illustrates the testing procedure.

Figure 12: Air-coupled impact-echo testing of pedestal in Building 19.

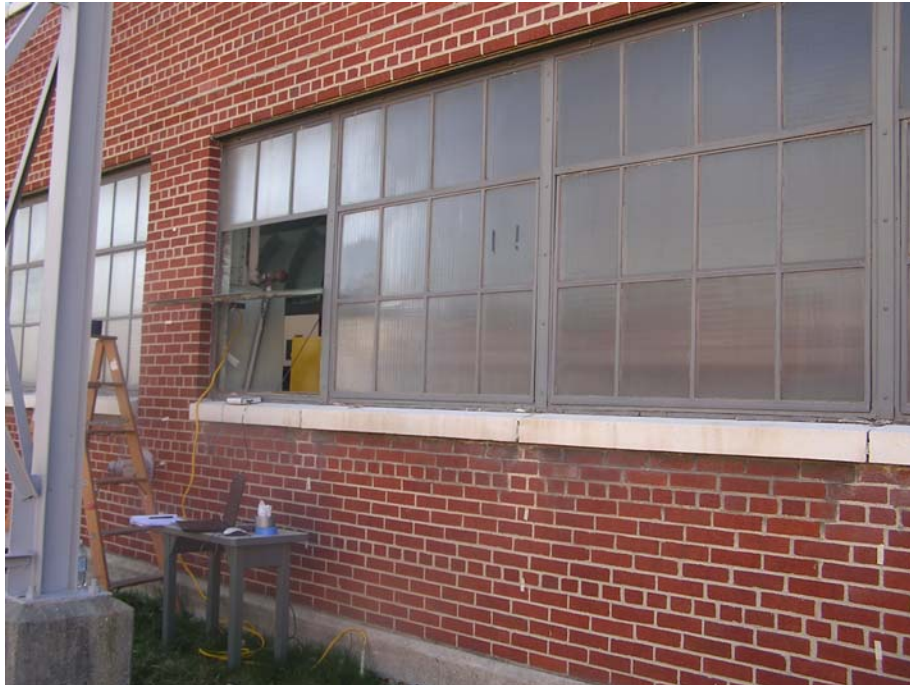
The two wythe brick infill walls of Building 19 were subjected to further air-coupled impact-echo testing. The walls are built in common bond, with six courses of stretchers, or bricks laid with the long face outwards, followed by a single header course, that is a row of through bricks, with the short face showing to the outside. This construction is shown in the photograph in Figure 13. The purpose of this testing was to determine the suitability of this method for the assessment of masonry structures. In general, masonry structures, having internal discontinuities, are more difficult to assess using this method, due to further difficulties in interpreting the spectra that result from the tests. The exterior wall of the building was subjected to a number of tests on a predetermined grid. Two bays of infill wall were tested, each according

Figure 13: View of one infill panel of the North wall of Building 19.

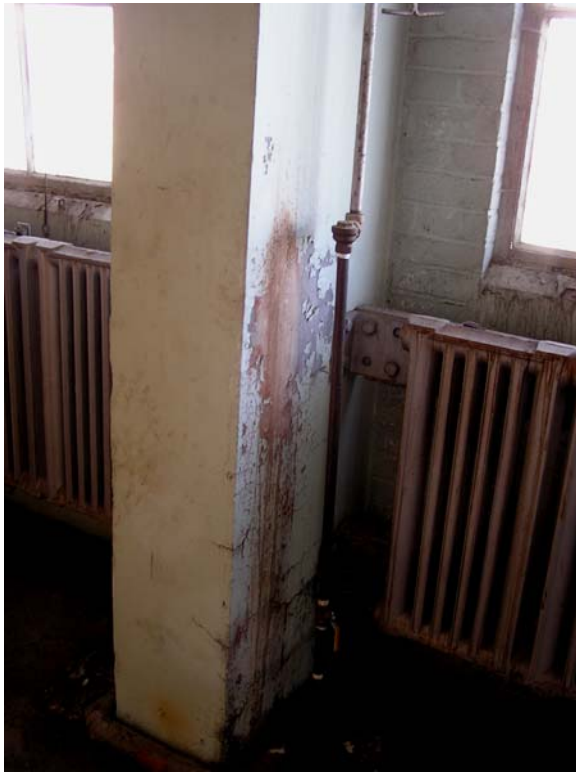
Figure 27: Pedestal 5 north: largely intact, with diagonal crack at 50".

5.1 kHz and very few higher-frequency return signals, indicating very little disruption of the sound wave through the thickness of the pedestal. If there were a reinforcing layer at the far side of the pedestal, it would show as a larger signal at a slightly higher frequency. Most tests on the pedestals in Building 19 did not show the presence of reinforcement. A spectrum (Figure 26) taken on the same pedestal in the region of a small, but apparent, crack shows the disruption in the pattern of frequencies caused by the internal crack. The additional peaks at 10 and 15 kHz indicate that sound waves are being reflected by an internal obstruction, such as a crack or an inclusion, at approximately one half (10 kHz) and one third (15 kHz) of the thickness of the pedestal. Illustrations of typical patterns of damage in the pedestals are shown in Figures 27 and 28.

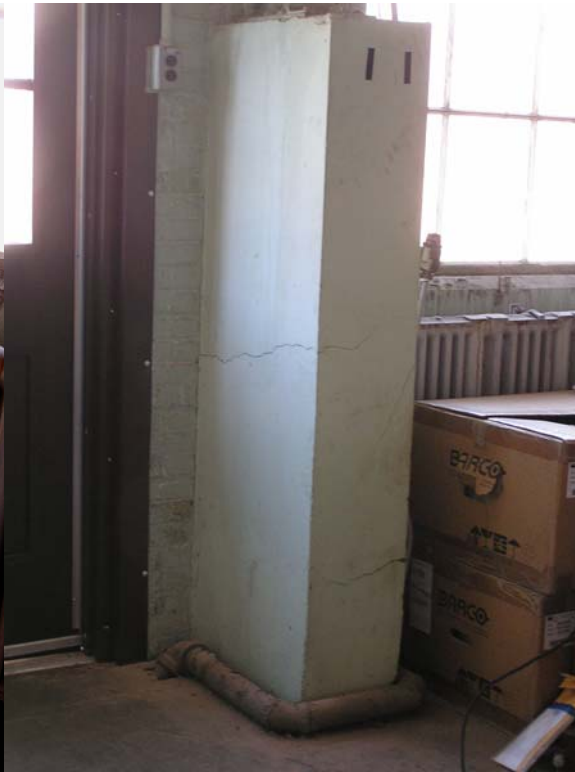
Figure 28: Pedestal 1 north: severely damaged pedestal.
